Refurbishment Asbestos Survey of: 47 and 48 St Mary's Street, Cardiff

Report no: NGA2017/S/092/R001

Issued: November 2017

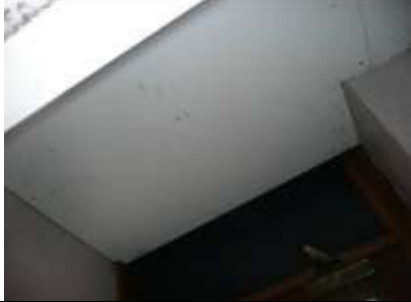
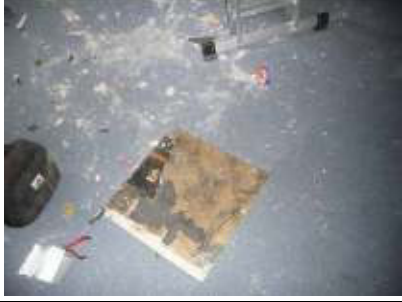
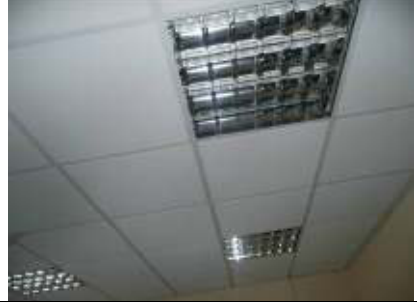
Sample 2017/S/092/S001 0/002 – Cement ceiling	Sample 2017/S/092/S002 1/002 - Bitumen	Sample 2017/S/092/S003 1/003 – Fibreboard tile

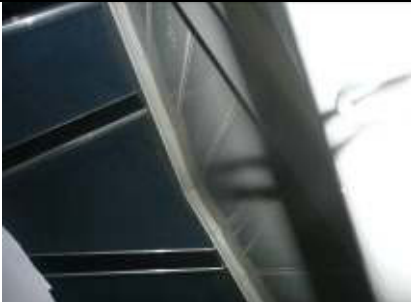
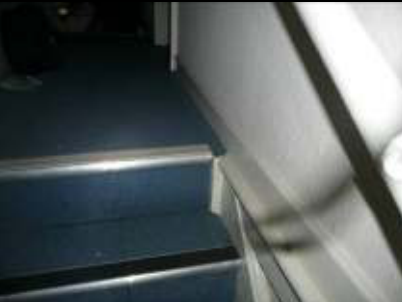
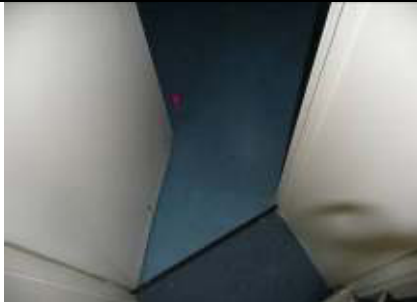
Sample 2017/S/092/S004 1/009 – Step nosing	Sample 2017/S/092/S005 1/009 - Step nosing	Sample 2017/S/092/S006 0/003 – Lino floor

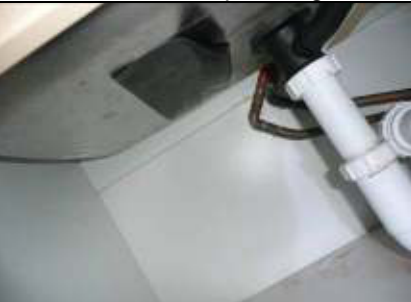
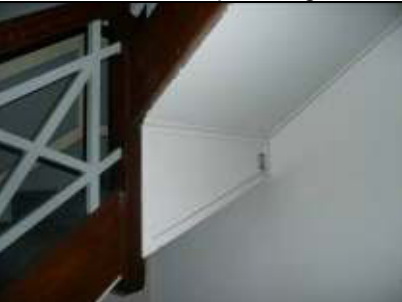
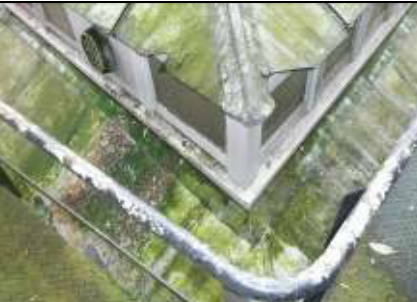
Sample 2017/S/092/S007 0/004 – Sink pad	Sample 2017/S/092/S008 2/001 – Cement ceiling	Sample 2017/S/092/S009 External – Bitumen felt

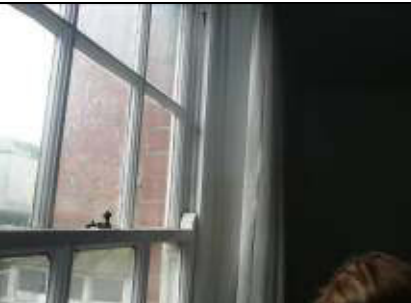
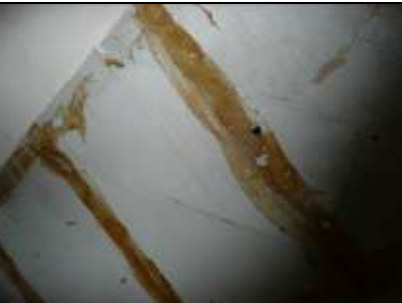
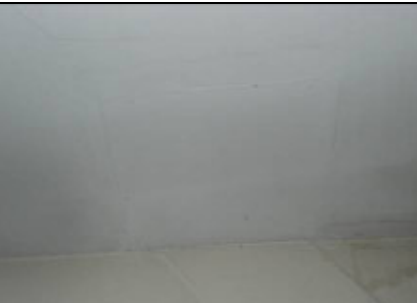
Asbestos insulating boards, containing Amosite & Chrysotile, were identified in rooms 2/006 and 3/004.

Sample 2017/S/092/S010 2/010 - Rope	Sample 2017/S/092/S011 3/004 – AIB panel	Sample 2017/S/092/S012 3/001 – AIB panel

This type of asbestos material is generally considered medium risk and should be removed fully controlled manner and disposed of according to the requirements of the Hazardous Waste Regulations 2009 prior to any refurbishment works.

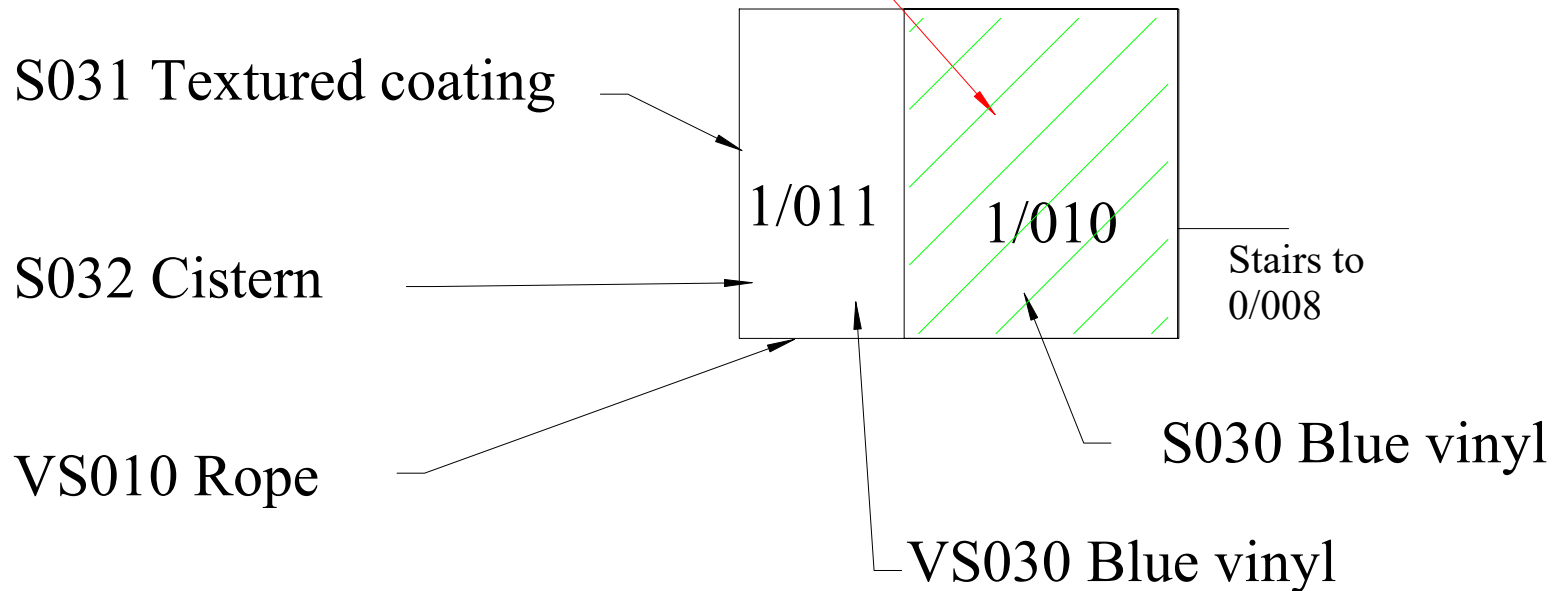
Drawing Ref: 2017/S/092/D006

VS029 Vinyl floor tiles (green)
